康特MCI滲透移動鋼筋阻鏽劑 應用於美國五角大廈

刊登標題：年度計劃：五角大廈的翻新—外牆與內部結構的修復

Project of the Year: PENTAGON RENOVATIONS— EXTERIOR WALL REPAIR AND INTERIOR STRUCTURAL REPAIR

Arlington, Virginia

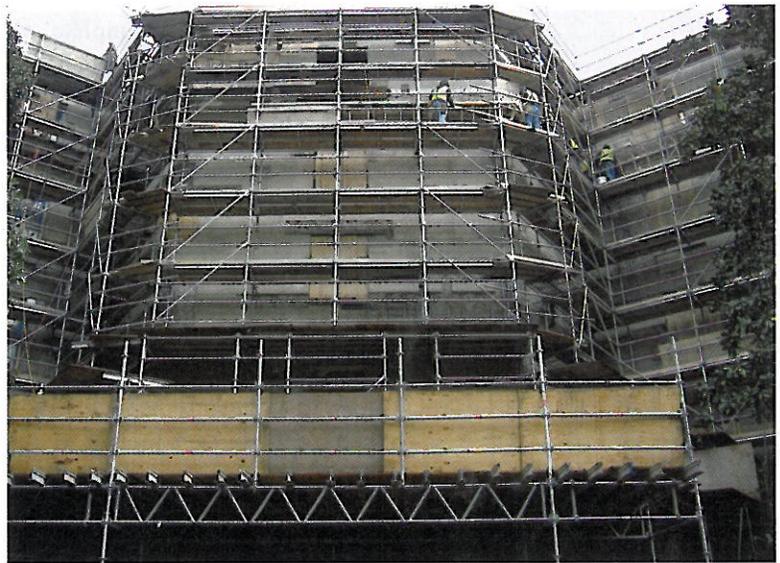
Repair crews working on Pentagon walls

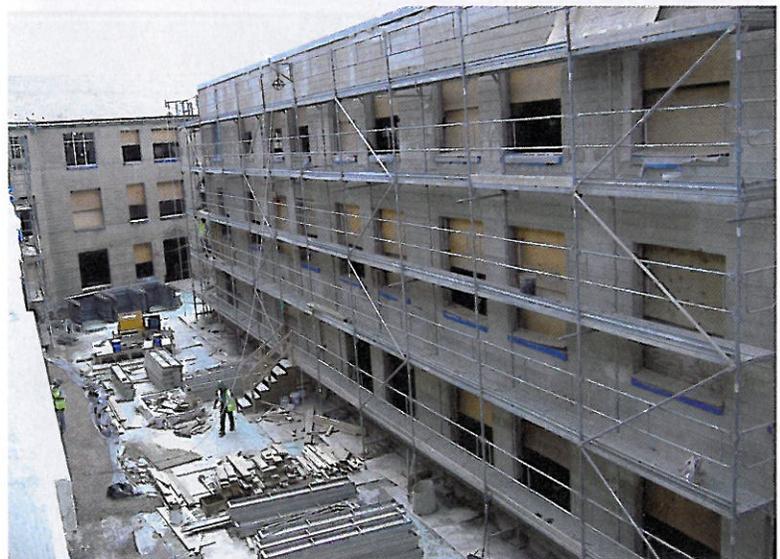
View of interior lightwell work area

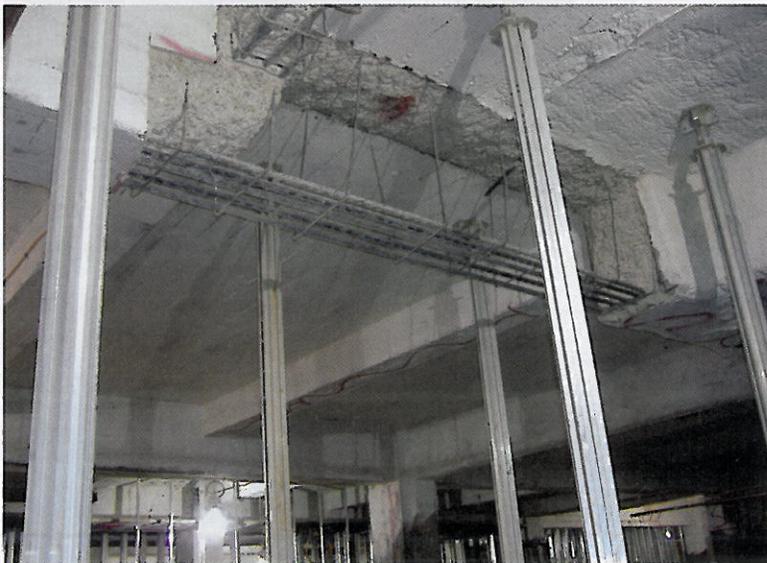
Interior beam repair work—notice the extensive shoring

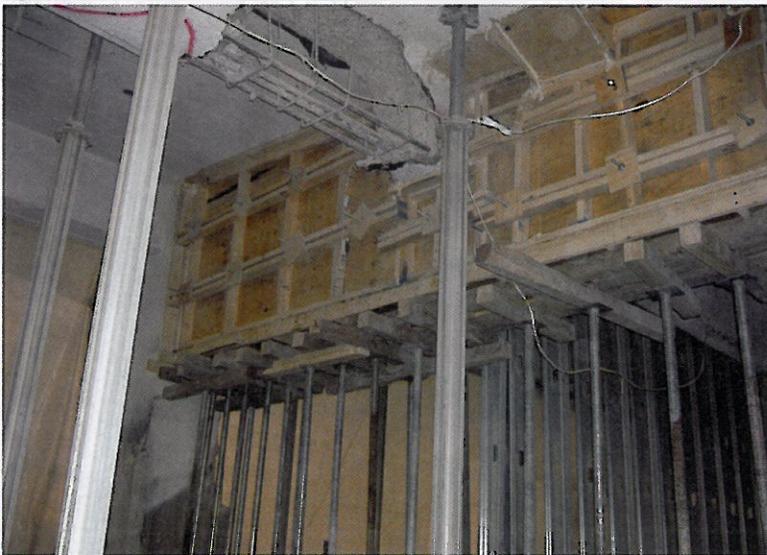
View of the full-depth beam repair

In one particular area, the removal of the interior finishes uncovered a large section of the second-floor structure that had been damaged by an historical fire. This unexpected repair required full-depth removal of beams and girders, some more than 4 ft (1.2 m) deep. After the floor slab was extensively shored, the damaged concrete was removed, the beams were formed, and ready mixed concrete was placed from the above level.

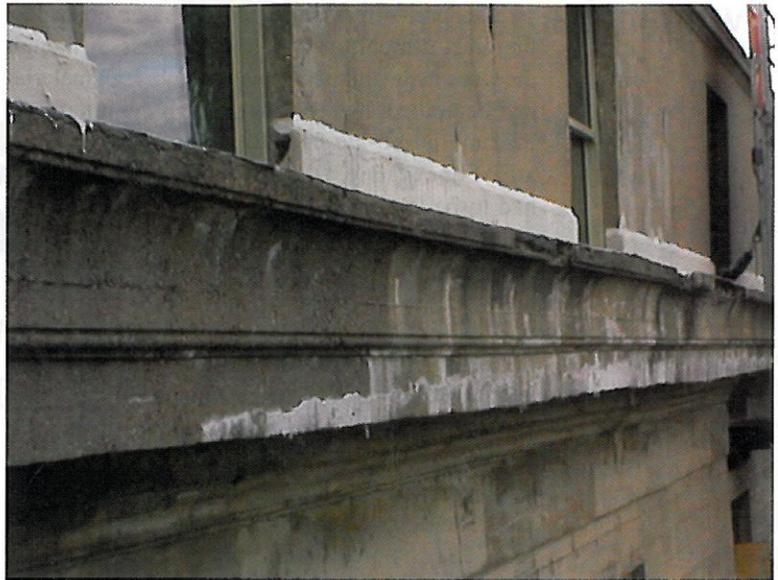
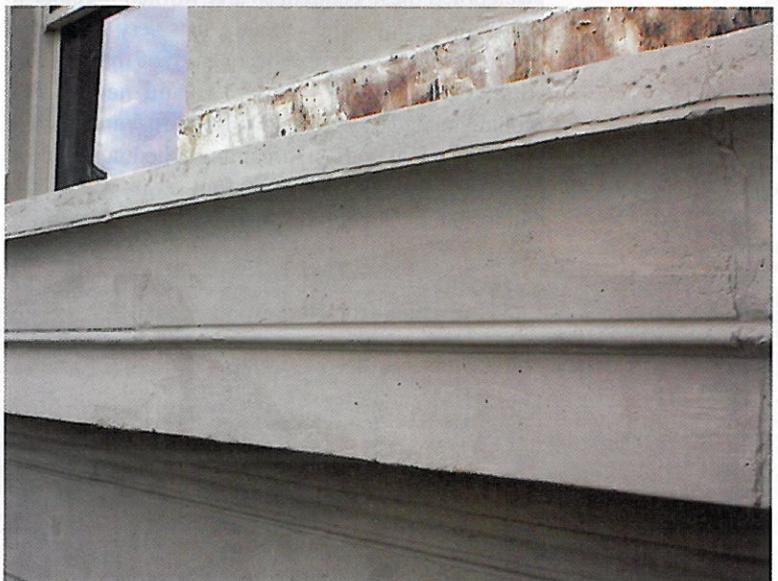
Close-up of repaired area on walls, before and after

- In areas of inadequate cover, the concrete was undercut and the reinforcing bar was recessed to provide a minimum of 1-1/2 in. (38 mm) cover; and
- After sandblasting, a corrosion inhibiting coating was applied to the reinforcing.

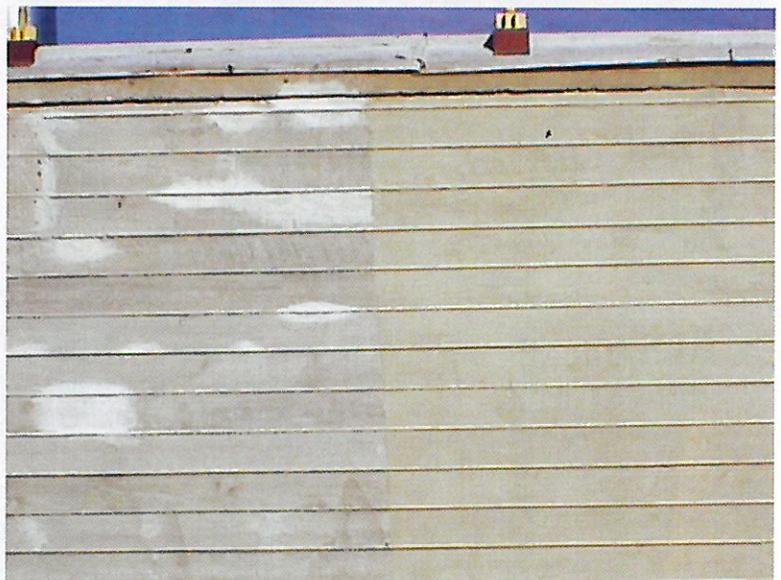
Before and after coating application

- A migrating corrosion inhibitor, selected to compensate for the loss of alkalinity around the reinforcing steel, was applied to the entire wall surface. This amino-based migrating inhibitor was topically applied to the concrete surface, and this water-based inhibitor penetrates the concrete’s pour structure through capillary action, causing it to diffuse throughout the concrete molecular matrix. Furthermore, the amino molecules have an ionic reaction with the reinforcing steel, causing a physical attraction creating a tenacious bond to the reinforcing steel, and thus recreating a passive layer of high alkalinity;

- After the application of the migrating corrosion inhibitor, a 100% silane sealer was applied to the walls to repel water and reduce moisture absorption; and

- A mineral-based coating was applied to provide a preventative waterproofing for the unrepaired concrete areas, protect the new repairs, act as further prevention against water absorption, and give the building a uniform appearance. This potassium silicate coating was chosen to form a chemical bond with the concrete, yet allow the cast-in-place structure to breathe and be permeable. The coating system chosen is high in pH to protect the reinforcing steel and concrete from carbonation.

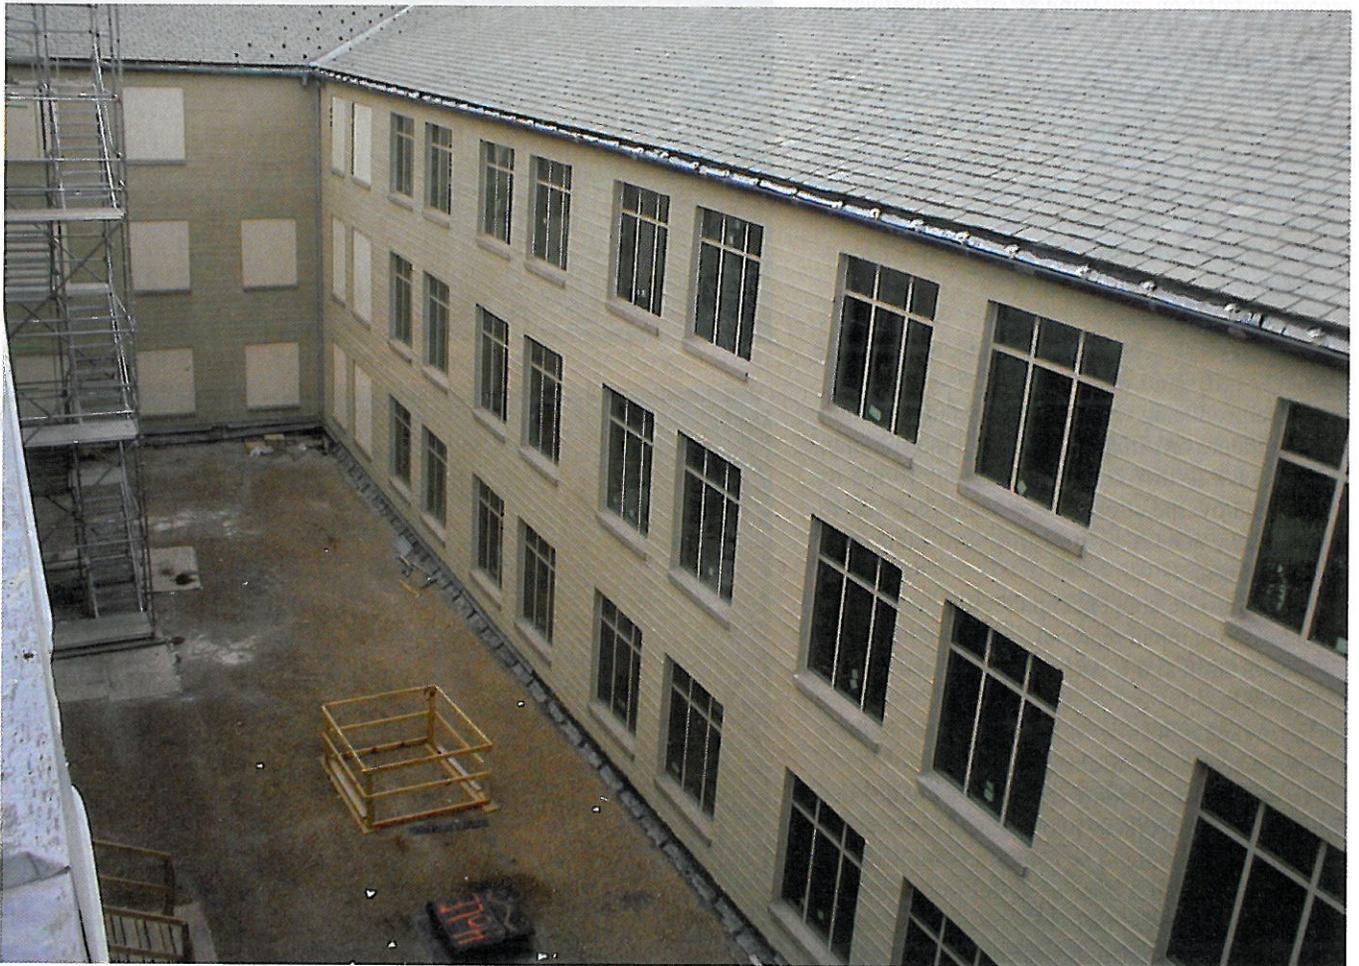
Completed repairs
