康特MCI滲透移動鋼筋阻鏽劑 應用於美國五角大廈

刊登標題：美國五角大廈採光牆—延長使用50年的修復、翻新與保護計劃

The Pentagon Lightwell Walls

Repair, Rehabilitation and Protection for the Next 50 Years

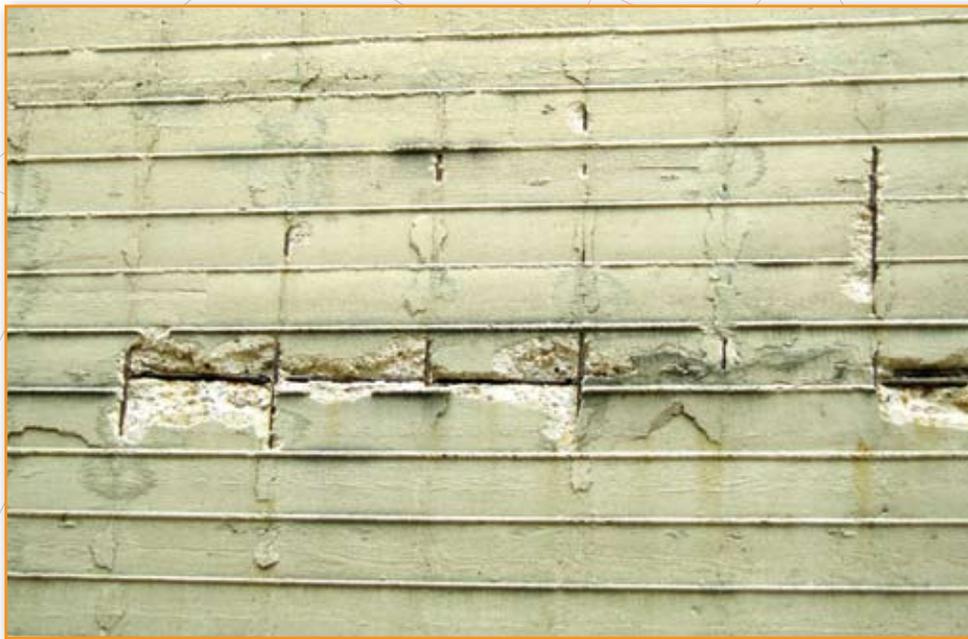
Figure 1: Typical lightwell wall damage showing spalling and exposed rusting reinforcing bars.

The problem is corrosion, i.e., rusting, of the reinforcing bars in the lightwell walls and related spalling damage caused by the expansive forces created by the rusting bars. As steel rusts, it expands 4 to 10 times its original size creating extreme tensile forces in the surrounding concrete. From these tensile forces, the concrete cracks the spalls. The Pentagon program is about the repair and rehabilitation of the more than 250,000 square feet of spalling, typically represented in *Figure 1*, plus an innovative protection system designed to resist the damage for the next 50+ years.

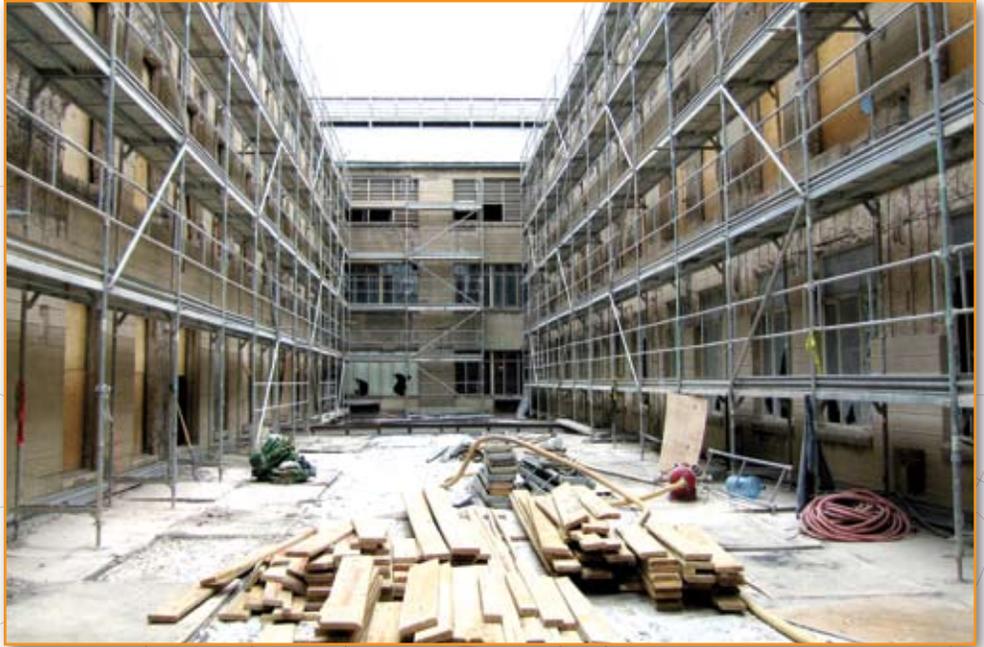
Figure 2: Scaffolding constructed to allow direct access to walls.

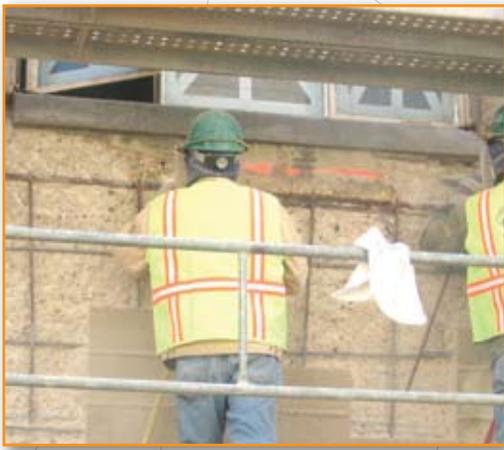
Figure 3: Jackhammer demolition in progress exposing corrosion damaged reinforcing bars.

The Structural Engineer of Record for the concrete repair program designed the concrete repair work closely following the International Concrete Repair Institute guidelines for concrete repair. All damaged and spalling concrete, some 3 to 4 inches deep, is removed with 15-pound jack hammers, fully exposing rusting reinforcing bars. Where corrosion has extended around a bar, the bar is undercut; this allows the full surface of the bar to be sandblasted clean, removing all rust. Working closely with U.S. Concrete Products, Timonium, MD, the manufacturer of the repair concrete, a color matching, low shrinkage, pumpable repair concrete was developed to comply with the Specifications which require a color and texture match when viewed from a distance of 30 feet (the view from any window across a lightwell). This is easier said than done. Although some of the repairs are as much as 4 inches deep, some repairs are less than 1 inch deep, and some are too small to economically build formwork. For the minor amount of hand patching that is being performed on small repairs, a trowelable mix was developed. For the remaining repairs, U.S. Concrete developed a polymer modified, plasticized, bagged material that is mixed onsite. This material easily flows into the formed repairs with extremely little shrinkage cracking. The mix allows repairs up to 4 inches deep without large aggregate extension, and almost no cracking. Simple external vibration is all that is needed for good consolidation. And, it obtains at least 2000 psi in under 3 days, to allow for early stripping.

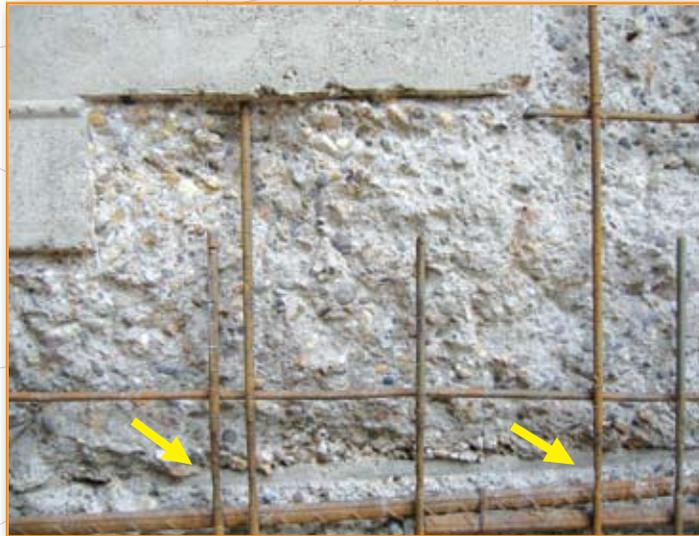
Figure 4: Close view of corrosion damaged reinforcing bars taken after completion of jackhammer demolition. Note the severe loss of cross section at the bottom of the vertical bars in the photo.

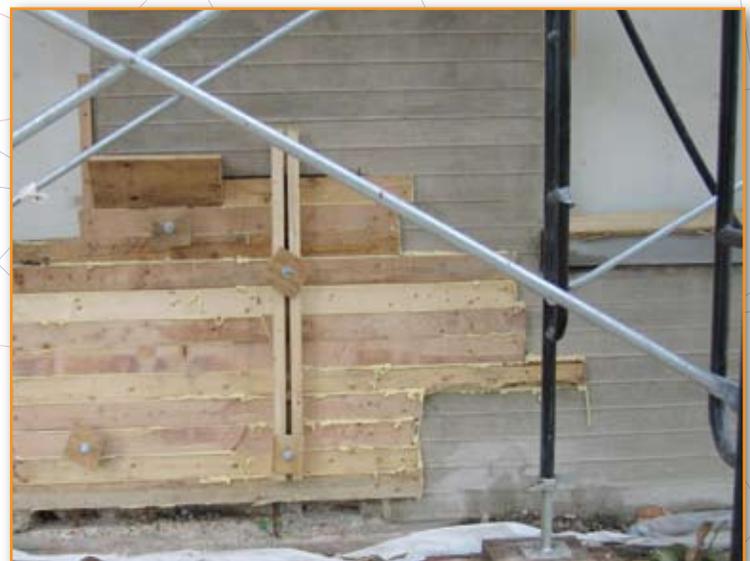
Figure 5: Formwork in place constructed to match original formboard finish on the existing walls.

Concrete Protection and Restoration, Inc., the concrete repair subcontractor, developed a formwork system (Figure 5) which allows easy placement of the repair concrete, as well as a match to the original form board finish. After

trial and error, they quickly learned that the best method of forming was to use the same 2x12 board construction, just like the original contractor did in 1944, thus creating a perfect match to the original finish.

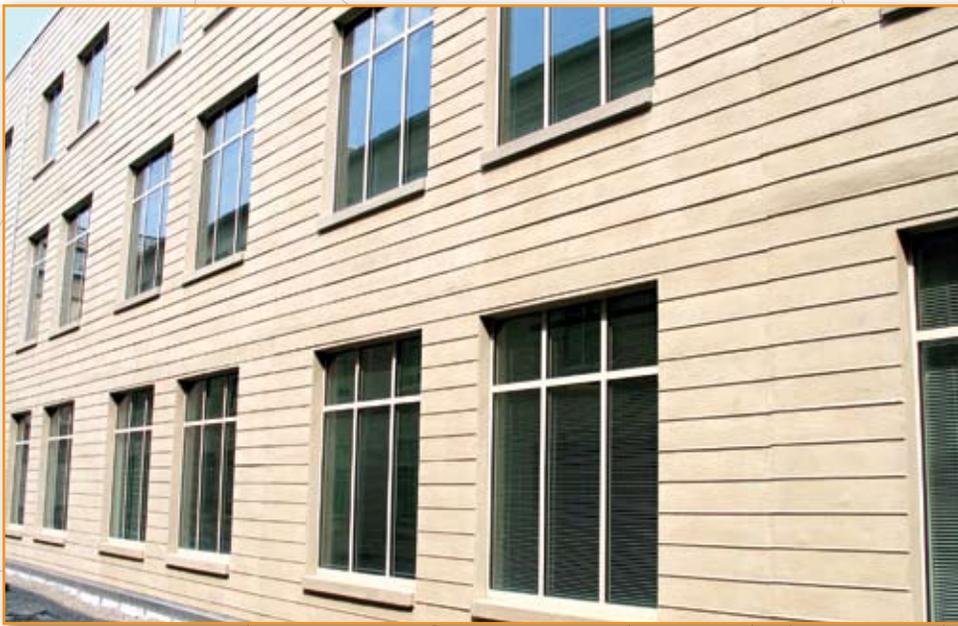
Figure 7: Complete wall ready for presentation.

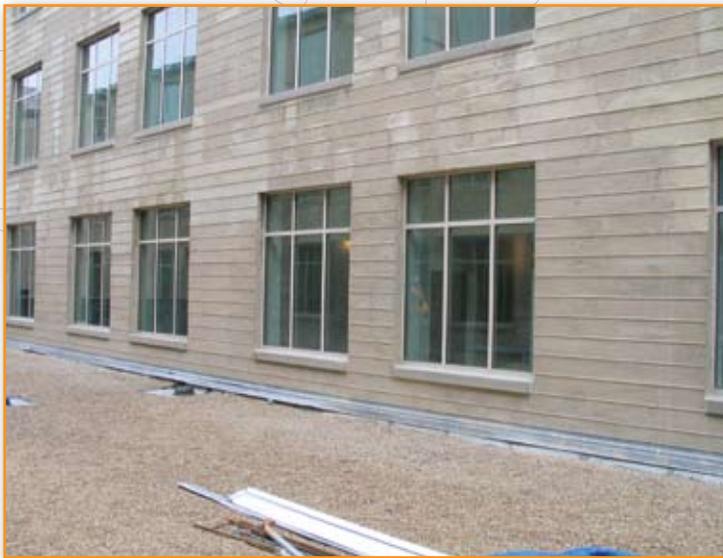
Figure 6: Portion of wall completed prior to application of silane and potassium silicate coating.

But, corrosion rate reduction is only half the battle. Without water, corrosion can be halted. How to stop water from absorbing into the walls for 50 years? Further protection is provided by a system reducing the absorption of water into the walls. A 100% solids silane is applied to the wall surface, after the application of the corrosion inhibitor, to reduce absorption and to repel water. Silane is a water repellent only and breaks down when exposed to ultraviolet light. To further protect the walls, a much more durable surface is needed, one which will last 50+ years and will prevent the breakdown of the silane. To accomplish this, potas-

sium silicate was selected to enhance the surface and to protect both the water repellent and the corrosion inhibitor. Potassium silicate, originally developed and manufactured in Germany by Keim over 100 years ago, is reported in their literature to remain in service today 100 years later. The potassium silicate itself also resists water absorption by creating a tough, water resistant mineral surface on the concrete. With both the potassium silicate and the silane, water now sheds off the surface of the concrete. In addition, a uniform color is achieved with the addition of pigments to the potassium silicate, further improving the repair to meet the required Specification of a color match as seen across the lightwells.

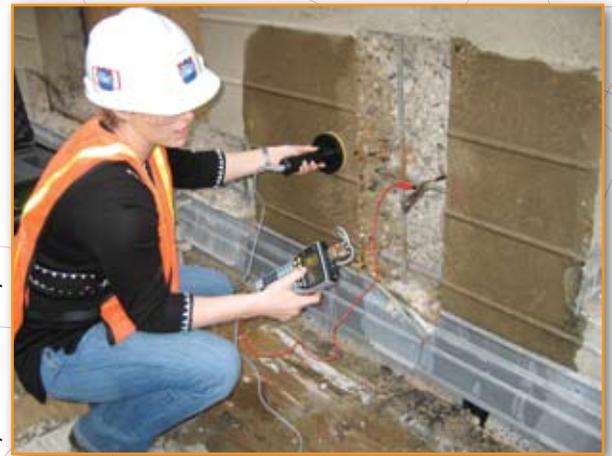
Figure 8: Corrosion rate monitoring of corrosion activity in unrepaired portion of wall adjacent to exposed corrosion damage.

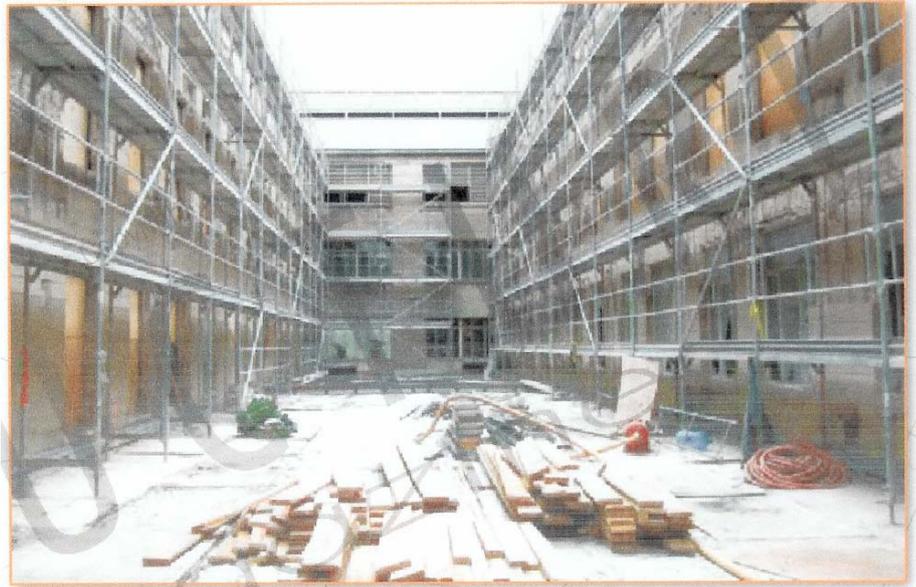
圖 1：搭鷹架以利直接在牆面上施工

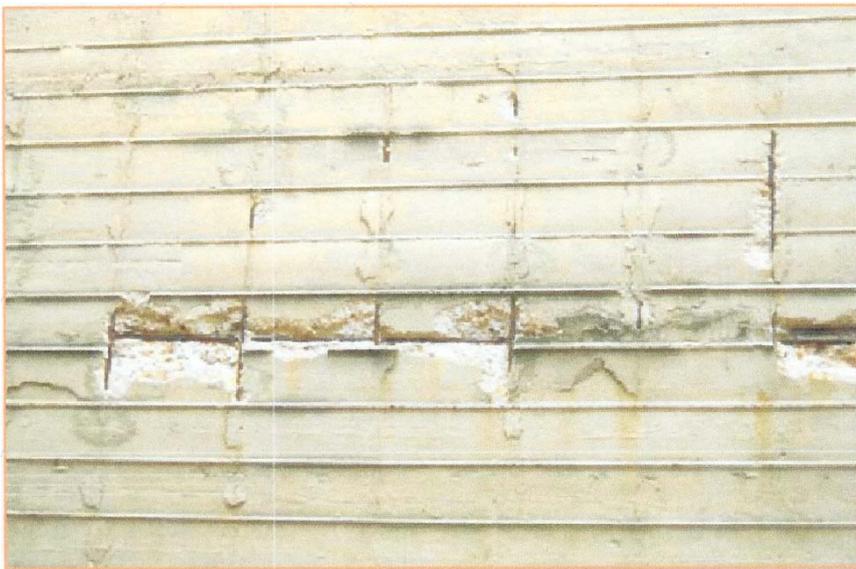
圖 2：一般採光牆損壞後所顯現的剝落現象與暴露的鏽蝕強化鋼筋

採光牆中強化鋼筋的鏽蝕以及鏽蝕鋼筋產生膨脹所造成混凝土的剝落損壞係最大的問題。當鋼筋鏽蝕時，其體積將膨脹4~10倍，而對周圍混凝土產生極大的張力，造成混凝土龜裂損壞。五角大廈的計劃係進行250,000平方英尺以上如圖2所示剝落混凝土的修復與翻新，同時設計採用最新的保護工法，以抵抗後續50年內遭受損壞。

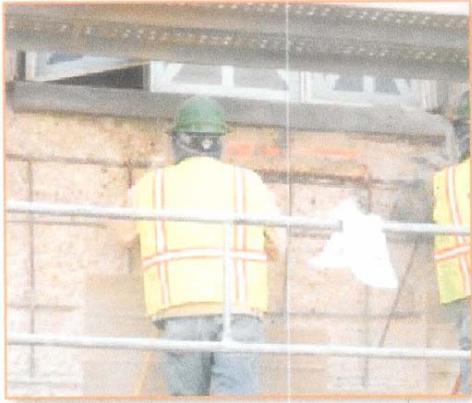
圖 3：以千斤鎚敲除腐蝕的強化鋼筋

記錄混凝土修復計劃的結構工程師，遵照國際混凝土修復協會所訂定的混凝土修復指南，嚴格地執行此工程的修復計劃。所有已損壞與剝落的混凝土，甚至深達3~4英吋，皆以15磅的千斤鎚將其敲除，使鏽蝕的強化鋼筋

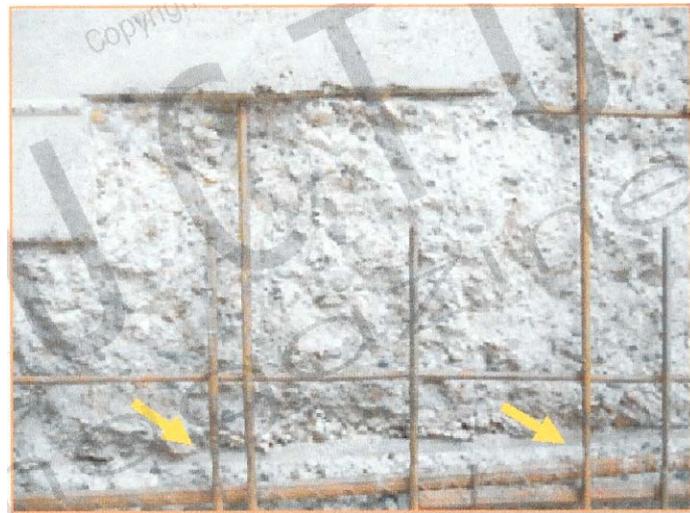
圖 4：千斤鎚完成敲除腐蝕強化鋼筋的近照，箭頭所指為底部十字交叉處，垂直鋼筋已嚴重損壞。

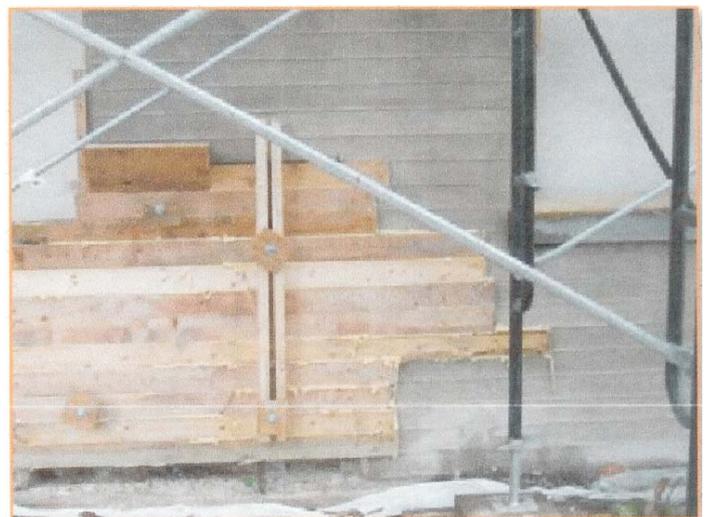
圖 5：在適當位置建造與原模板飾面相稱之新模板工程

修復混凝土的分包商 Concrete Protection and Restoration, Inc., 公司開發出一種模板工程工法(圖5)，其易於澆置修復用的混凝土，且能與原建模板飾紋相稱。歷經數次的試驗失敗，他們迅速地瞭解最佳的修復方法即是使用與1944年原承包商所使用相同的2x12模板建造工法，因而成功地作出完全相稱的飾面。

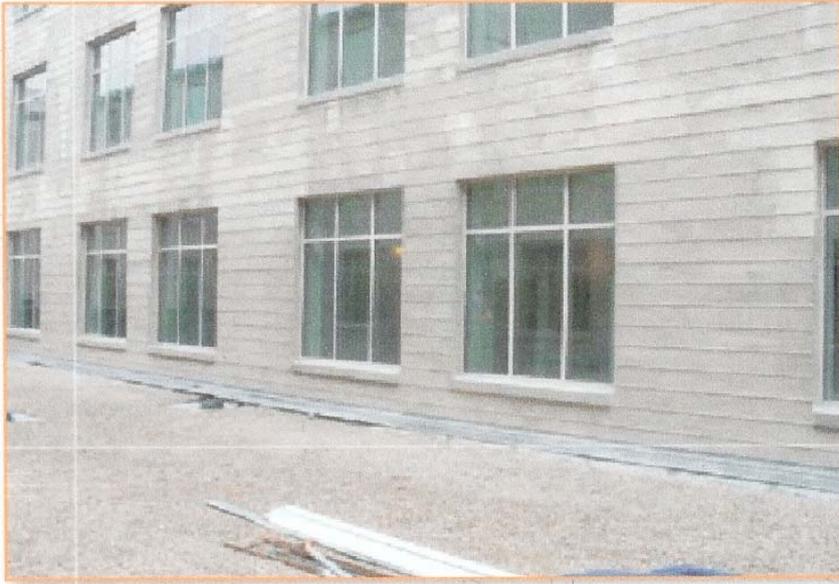
圖 6：完成防蝕的牆面，但未完成矽烷與矽酸鉀塗料的塗佈。

然而，降低腐蝕速率僅達到一半的阻鏽功效，阻止水份的吸收才可使腐蝕完全停止。如何阻止水份吸收入牆面長達50年之久呢？下一步的保護是提供減少水份吸收入牆面的工法。在MCI阻鏽劑噴塗後，於外牆面再噴塗100%固體的矽烷，將可降低水份的吸收並撥除水份。但

矽烷只具撥水功效，當暴露於紫外線下即易遭破壞。為進一步保護牆面，需使用一種更具耐久性的表層塗料，不但可維持50年壽命且可防止矽烷損壞。為達到此要求，則選定矽酸鉀以強化表面，並同時保護撥水層與防蝕層。矽酸鉀係100多年前由德國 Keim 公司所研發與製造，當年其說明書中曾提及此產品而100年後的今天仍舊使用。矽酸鉀本身在混凝土表面上可形成一層堅韌與防水的無機表面，而具抵抗水份吸收的特性。經矽酸鉀與矽烷的雙重保護，水份可

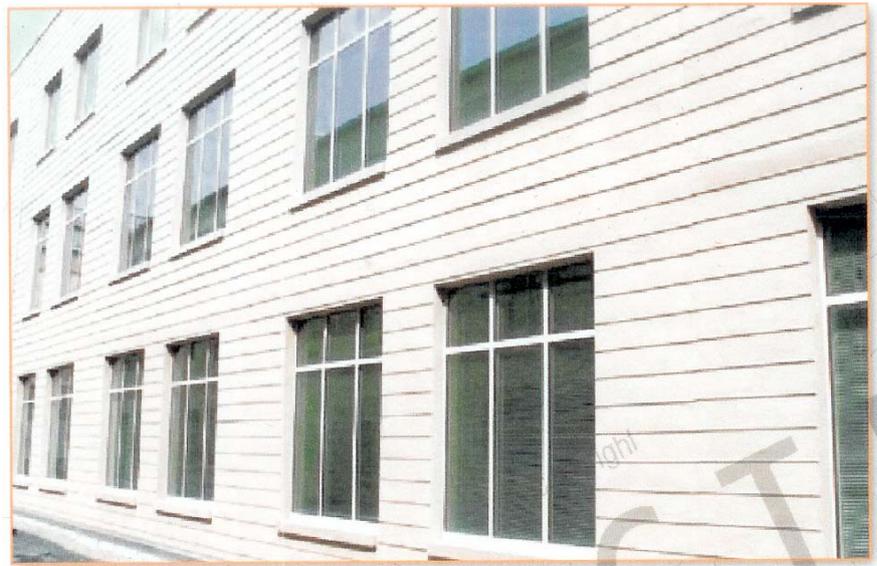
圖 7：完成的展示牆面。

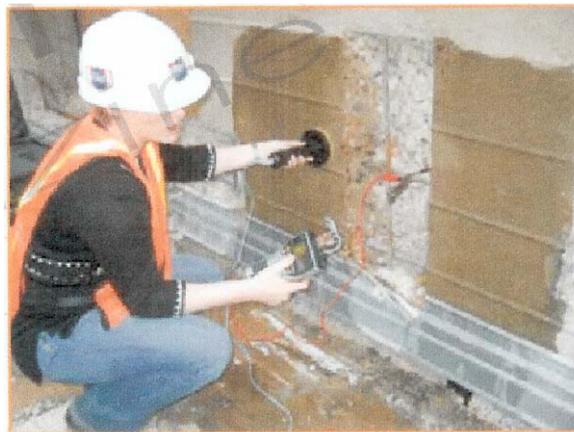
圖 8：以腐蝕速率偵測器偵測遭腐蝕損壞處的鄰牆，其未修繕下的腐蝕活動情況。
